Preliminary Hand- Held Air Monitoring Locations | ITC Deer Park Tank Fire

3/31/2019 2:00:00 AM to 3/31/2019 3:00:00 AM

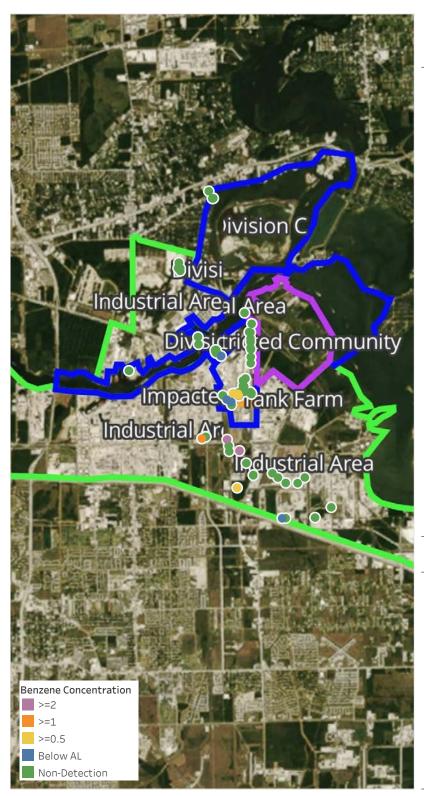
Recent Benzene Detections

Location Category	Reading Date	Concentration
Division E	3/31/2019 02:48:12	0.53 ppm
	3/31/2019 02:35:17	0.75 ppm
	3/31/2019 02:31:37	0.98 ppm
	3/31/2019 02:28:10	0.04 ppm
	3/31/2019 02:27:53	0.21 ppm
	3/31/2019 02:20:06	0.27 ppm
	3/31/2019 02:18:27	0.60 ppm
	3/31/2019 02:17:57	0.30 ppm
	3/31/2019 02:16:09	0.90 ppm
	3/31/2019 02:13:53	0.30 ppm
	3/31/2019 02:10:33	0.59 ppm
	3/31/2019 02:10:04	0.28 ppm
	3/31/2019 02:06:49	0.09 ppm
Impacted Tank Farm	3/31/2019 02:04:22	0.83 ppm
Industrial Area	3/31/2019 02:30:07	0.35 ppm
	3/31/2019 02:27:52	1.40 ppm
	3/31/2019 02:21:22	0.10 ppm
	3/31/2019 02:19:48	12.55 ppm
	3/31/2019 02:04:14	2.13 ppm
	3/31/2019 02:00:32	1.33 ppm

Benzene Action Level Concentration (ppm) >=1 >=2

Recent Benzene Detections Greater than 1.00 ppm

Reading Date	Location Category	GPS	Google Maps URL	Concentration
3/31/2019 02:27:52	Industrial Area	29.7218540,-95.1040370	https://www.google.com/maps/search/?api=1&query=29.7218540,-95.1040370	1.40 ppm
3/31/2019 02:19:48	Industrial Area	29.7216290,-95.0967860	https://www.google.com/maps/search/?api=1&query=29.7216290,-95.0967860	12.55 ppm
3/31/2019 02:04:14	Industrial Area	29.7187880,-95.0932280	https://www.google.com/maps/search/?api=1&query=29.7187880,-95.0932280	2.13 ppm
3/31/2019 02:00:32	Industrial Area	29.7187890,-95.0932240	https://www.google.com/maps/search/?api=1&query=29.7187890,-95.0932240	1.33 ppm
